TECHNICAL MEMORANDUM

TO: RACHEL CALABRO, RIVERWAYS PROGRAM TAUNTON RIVER WILD & SCENIC LIAISON
FROM: BRIAN GRABER, FLUVIAL GEOMORPHOLOGIST, RIVERWAYS PROGRAM
SUBJECT: TAUNTON RIVER ASSESSMENT
DATE: 12/14/2004
CC: JOAN KIMBALL, RIVERWAYS PROGRAM DIRECTOR

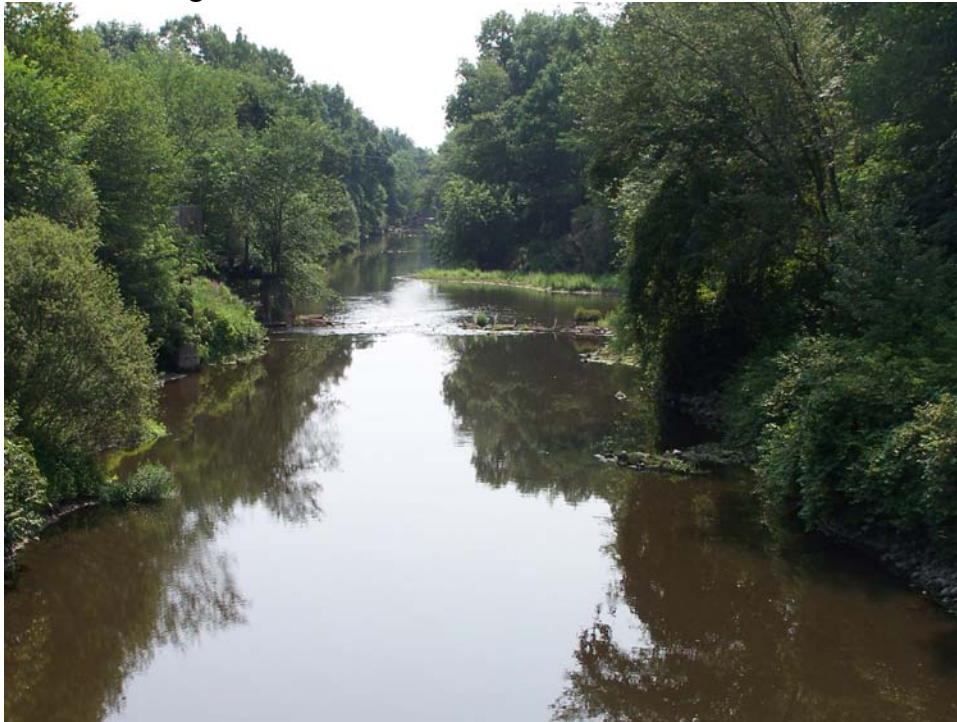
- Small, failing, partially breached structure, only 2 feet hydraulic head – breached near river left
- Dam breach may be velocity barrier
- Owner has expressed wanting possibility of low head hydro facility at dam – could calculate head at the site and compare to potential energy production to show that facility would likely be uneconomical
- Non-jurisdictional
- Note the high turbidity in the picture below – may be suspended sediment coming from the Matfield

Figure 1. Plymouth Street Dam

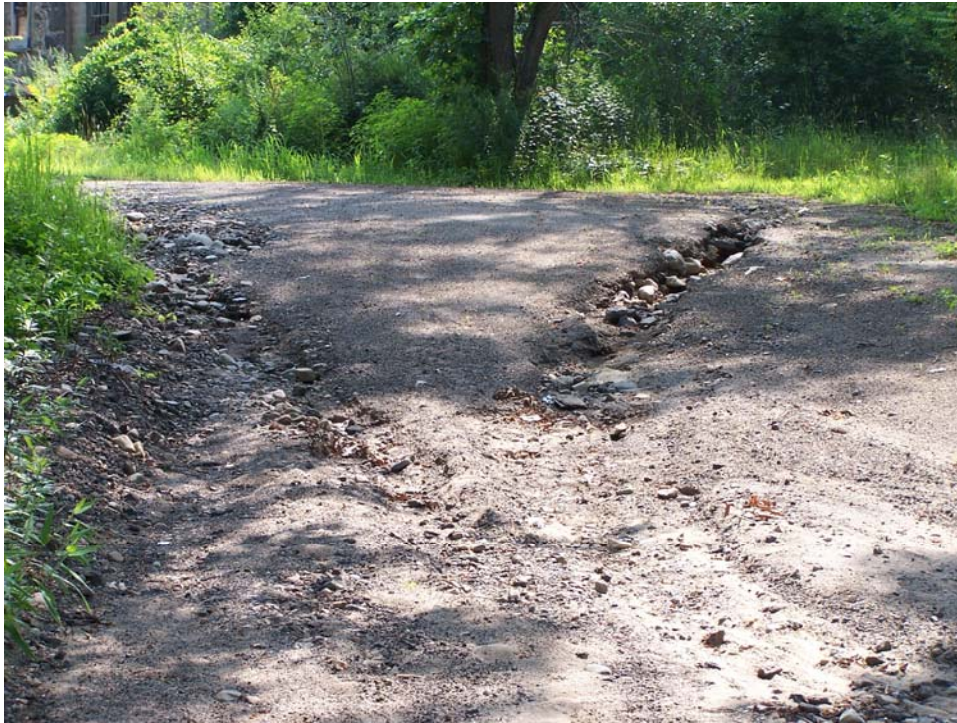
- Town River Dam (AKA High Street Dam)
 - At the Bridgewater Highway Department
 - Really 2 dams with a fish ladder
 - Fish ladder on upstream structure appears to be a barrier at lowflow – perched on both upstream and downstream ends – may be passable at high flows
 - Significant hazard dam in poor/fair condition
 - Inspected in 1998 and no repairs have been made
 - Dirt road is eroding into the river here

Figure 2. Dirt Road eroding into river at Bridgewater Highway Dept

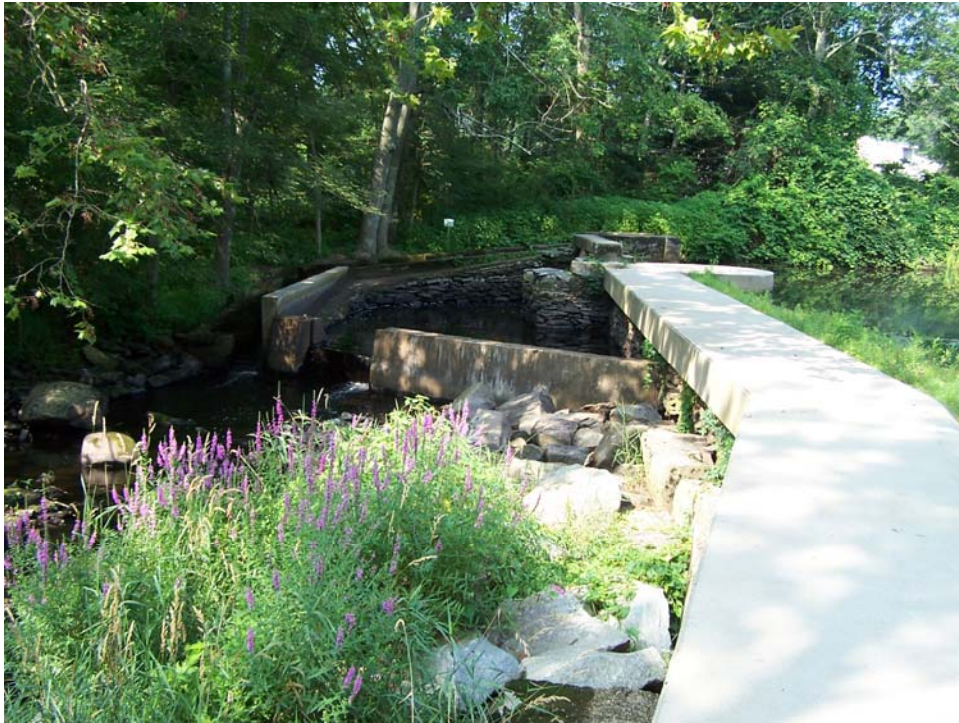
- War Memorial Dam
 - Dam is multiple structures with control boards in three different places
 - Attractive structure in pretty park
 - Fishway is inadequate
 - Dam is in poor condition – seepage through structure
 - Impoundment is full of organic muck on surface and bottom – may be sucking up oxygen

Figure 3. War Memorial Dam

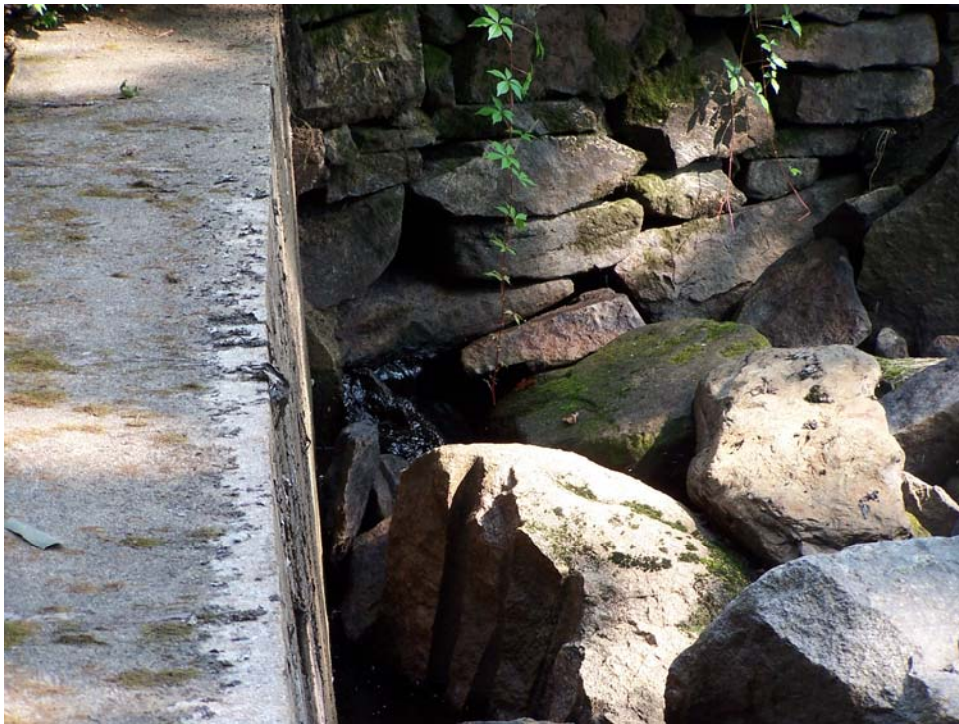
Figure 4. Seepage through War Memorial Dam

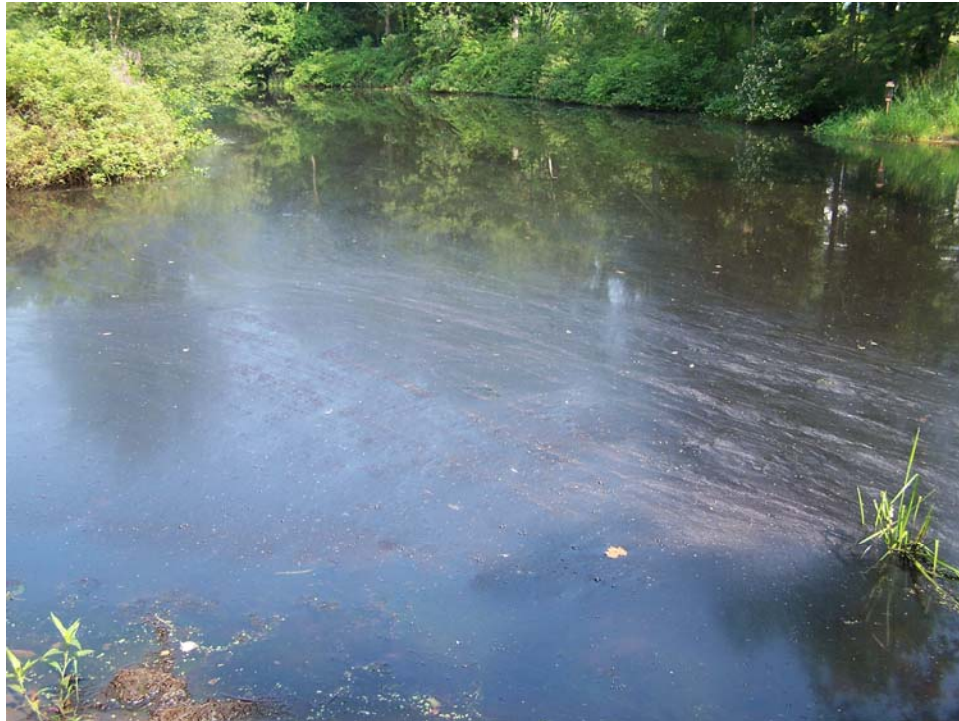
Figure 5. Organic material on water surface of War Memorial Dam impoundment

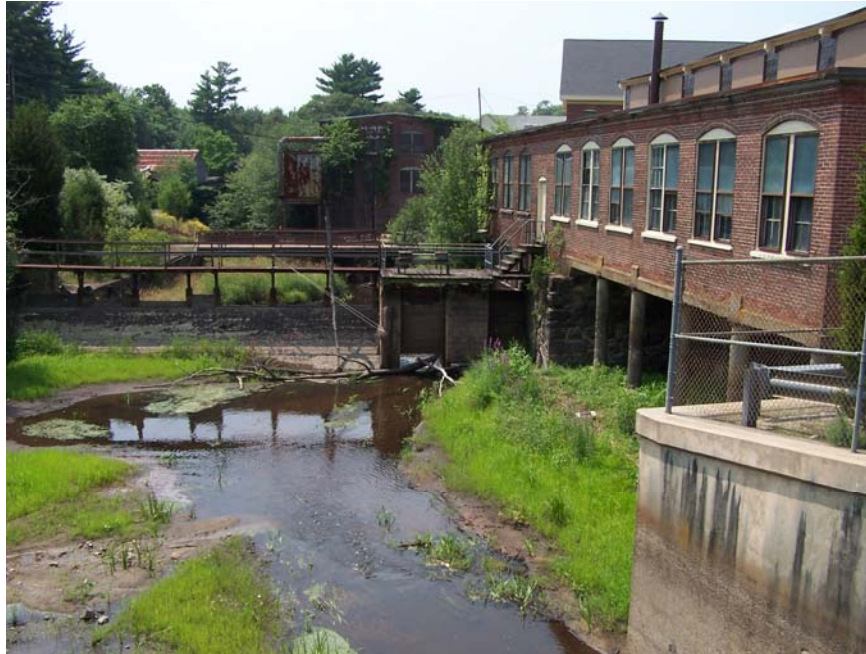
- Meadow Brook
 - Forge Pond Dam
 - Fish ladder is in poor condition and is not passable
 - Just downstream is a culvert/dam at Willow Ave that is impassable at low flow
- Satucket River
 - Cotton Carver Dam
 - Dam has breached and impoundment drained
 - Its removal would open up a large amount of habitat and many tributaries. Only one of the tributaries has a dam (Robbin Pond)

Figure 6. Cotton Carver Gin Mill Dam

- Owner is amenable to removal and towns are also in support – primarily need funding to proceed
- The mill building would make a nice riverside structure for a restaurant or some other business (I'd like the Cotton Carver Combo light on the mayo)
- Army Corps is beginning a Section 206 feasibility study
 - Project will be expensive and time-consuming with Corps involved
 - Could get out of the 206 and pursue other funding?

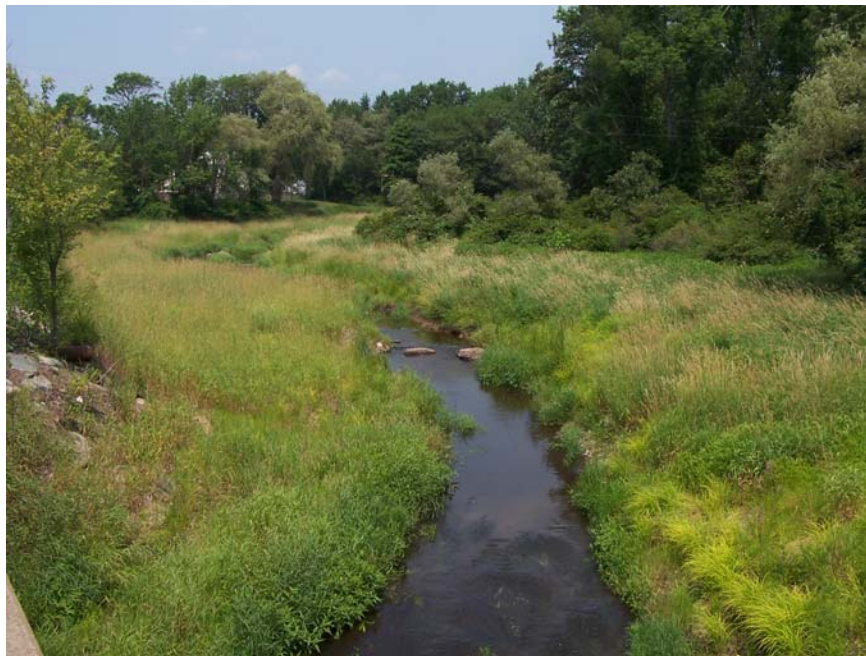
Figure 7. Channel forming in impoundment of Cotton Carver Dam

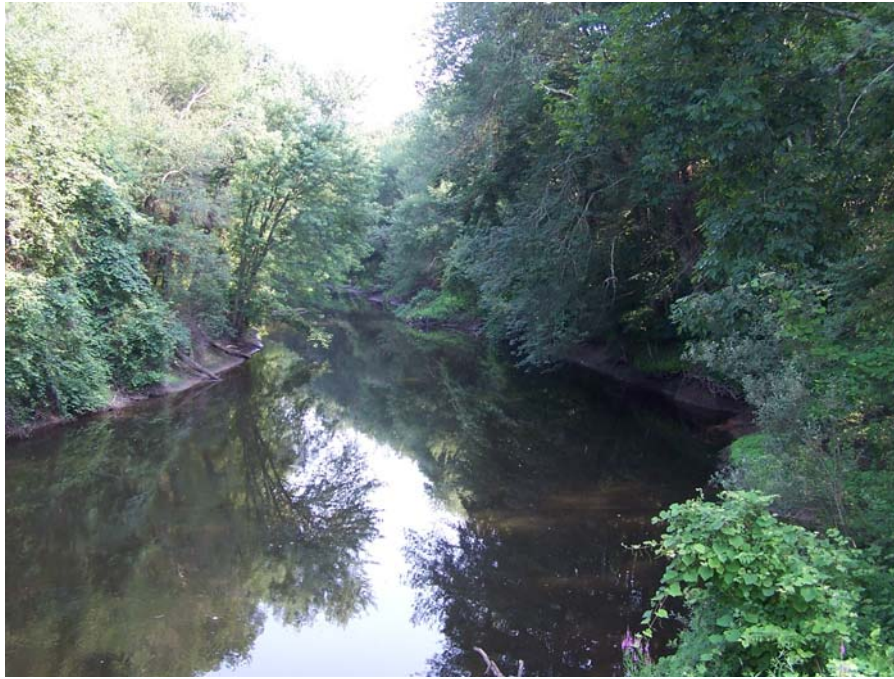
The upper portion of the mainstem Taunton River appears to be incised, such that flood flows go over the banks less frequently. This allows upland species to overtake near-bank areas, limiting riparian habitat and increasing erosive flood power by concentrating it within the stream channel (see Figure 8). Smaller tributaries that enter the river in this area appear to be perched, indicating that the incision has occurred at least in the last several decades. On the other hand, the middle portion of the river near the USGS stream gauge does not appear to be incised (Figure 9). This pattern represents a common sequence resulting from increased flow power due to land clearing and concentrated stormwater flows. Typically such rivers will have an incisional upper portion, a depositional lower portion, and a transitional middle portion. Both gauge information and the relative slope of the river bed can help identify where these portions occur.

Figure 8. Incised portion of mainstem Taunton near Cherry Street Bridge

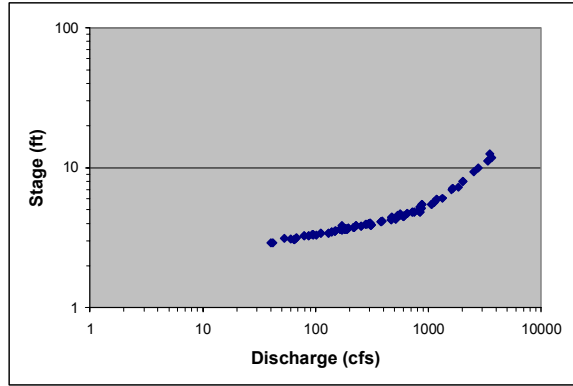
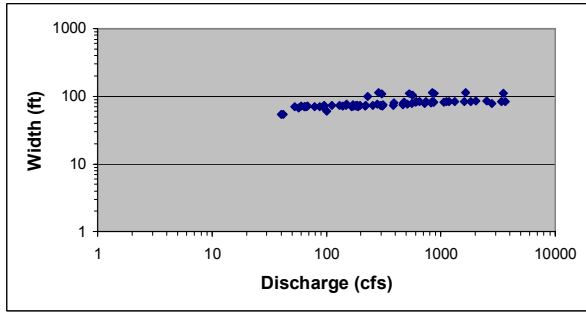
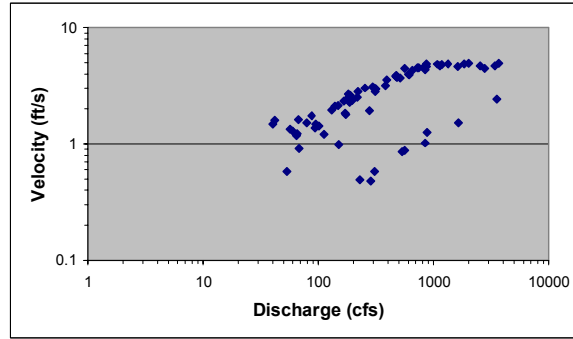
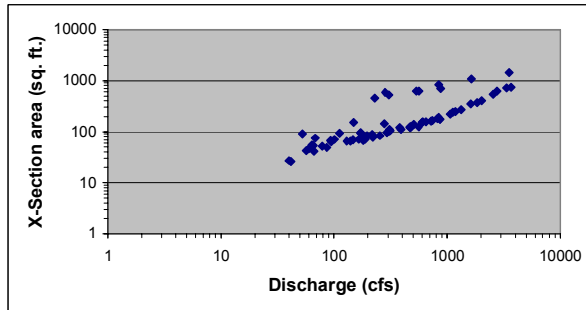
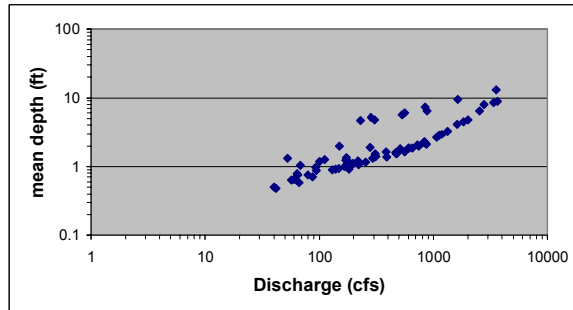
Figure 10. Preliminary bankfull estimates at the USGS Taunton River gauge

Figure 10 includes a flood frequency analysis, lowflow information, and preliminary bankfull estimates computed from USGS gauge data. ‘Bankfull’ refers to the surface where water first spills out onto the floodplain in more natural river reaches. Identifying bankfull on a degraded reach can show the degree of incision or deposition. For example, on an incised reach, bankfull will occur below the top of the banks. Bankfull typically occurs at the level of frequent floods between approximately the 1.2- to 2-year floods.

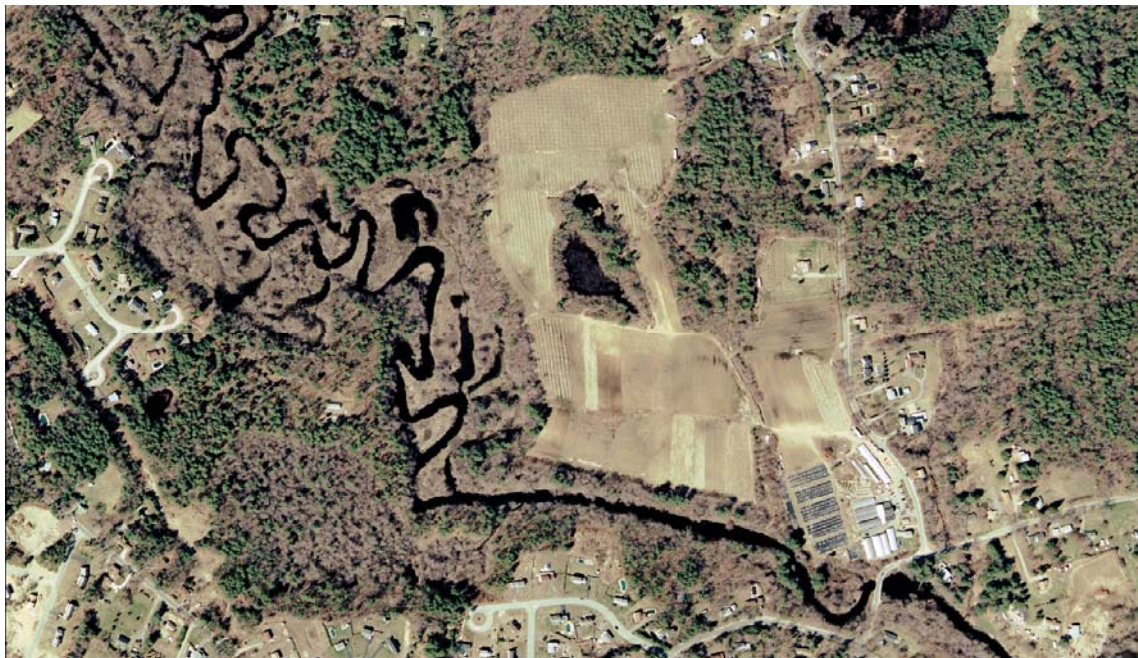
A recent Stream Team Shoreline Survey identified excessive bank erosion in the Matfield River upstream of Bridge Street. An air photo, shown below, provides some clear evidence about the cause of the erosion (Figure 11). Note the highly sinuous meandering pattern of the river in the upper left portion of the air photo. This highly sinuous pattern is naturally characteristic of low gradient broad floodplain rivers like this portion of the Matfield. However, the river continues through a much straighter reach as it approaches Bridge Street, which crosses the river in the bottom right portion of the air photo. This portion of the river was straightened at some time in the past, possibly to help drain water from agricultural fields or simply to move the river out of the way for farming. Channel straightening typically results in long-term erosion, as the same amount of water now flows over a shorter distance with less form resistance and therefore carries more erosive power than the same water winding through the meandering stretches. The channel here on the Matfield is gradually eroding to reform its meandering pattern. The river is preferentially eroding local outside bends and depositing on the inside of bends. This process contributes additional sediment to the river and will continue potentially for many years. Additional measurements would be necessary to estimate the quantity of sediment that is ending up in the river and thereby determine whether this erosion is significant on a watershed scale. Based on visual assessment, the Matfield does appear to carry greater suspended sediment than other tributaries, but this may result more from Brockton runoff.

Figure 11. Air photo showing meandering and straightened portions of the Matfield River

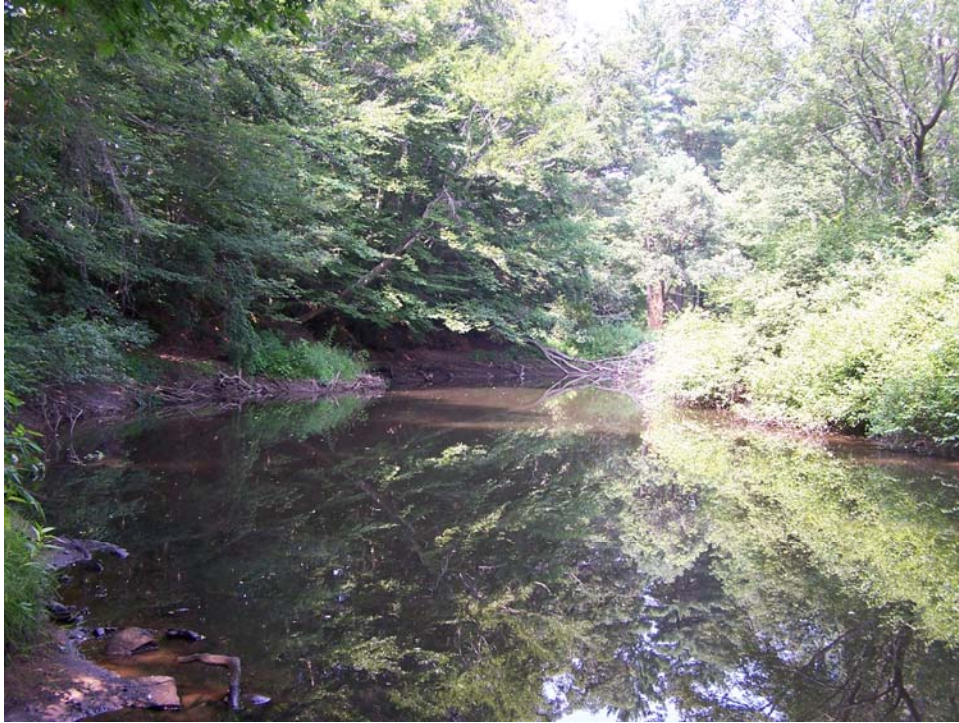
Figure 12. A portion of the Matfield River showing bank erosion at the downstream end of the straightened reach. Note particularly under the trees in the background.
